**Asbestos  
Management  
Group Ltd**  
Surveys and Consultancy

**LOCATION:**  
123 Street

# ASBESTOS REFURBISHMENT SURVEY

Report By	Asbestos Management Group Ltd
Client	Joe Bloggs
Project	Survey
Site Address	123 Street
Site Coordinates	51.1397852,0.8573831
Site Location

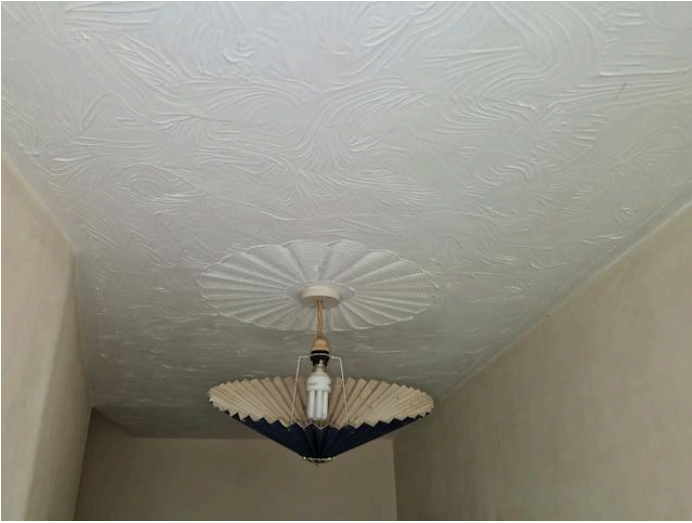
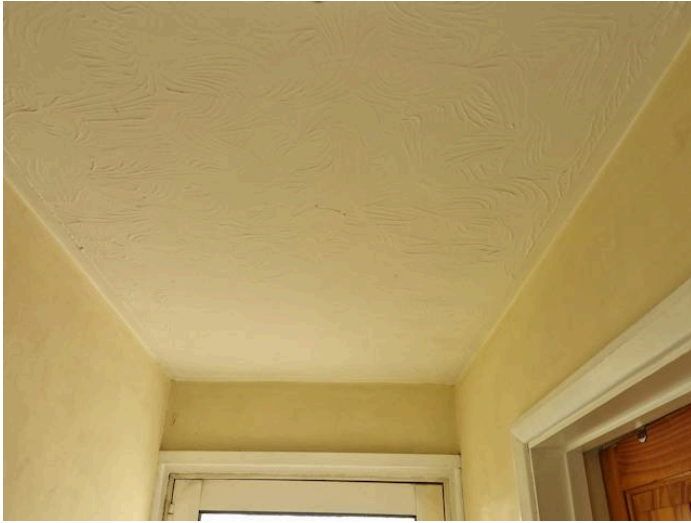
## Main Building > 0 > 010 - Hall > Textured coating to plasterboard ceiling

Building	Main Building	Level	0
Location	010 - Hall	Item	Textured coating to plasterboard ceiling
Material	Textured coating	Extent	8 m. sq.

Strategy / Sample Id	Strongly Presume / Sample 2	Presumed Fibre Type	Chrysotile
Recommendation	Remove if planned works may disturb

Product Type (or Debris from Product)	1	Extent of Damage / Deterioration	1
Surface Type / Treatment	1	Asbestos Type	1
Material Score	4 / Very Low

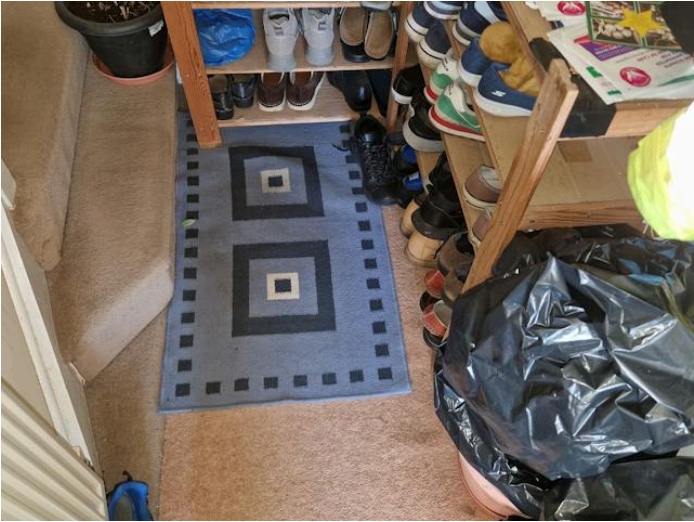
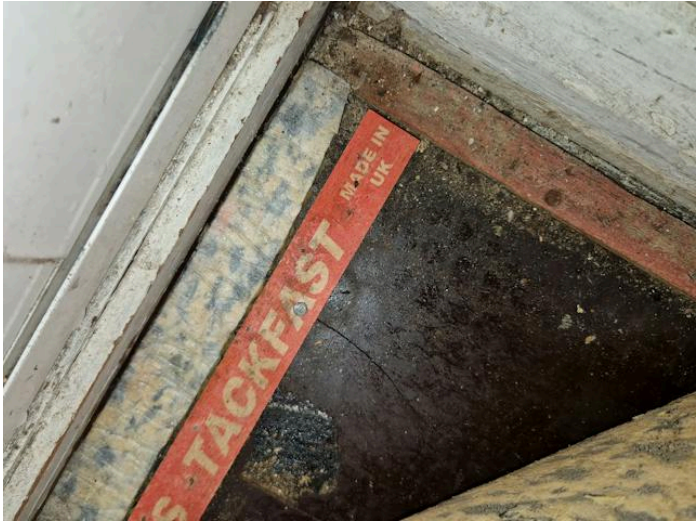
# Main Building > 0 > 010 - Hall > Floor tiles with bitumen adhesive beneath carpet

Building	Main Building	Level	0
Location	010 - Hall	Item	Floor tiles with bitumen adhesive beneath carpet
Material	Thermoplastic Floor Tile	Extent	8 m. sq.

Strategy / Sample Id	Sample / Sample 5	Fibre Type	Chrysotile
Recommendation	Remove if planned works may disturb

Product Type (or Debris from Product)	1	Extent of Damage / Deterioration	1
Surface Type / Treatment	0	Asbestos Type	1
Material Score	3 / Very Low

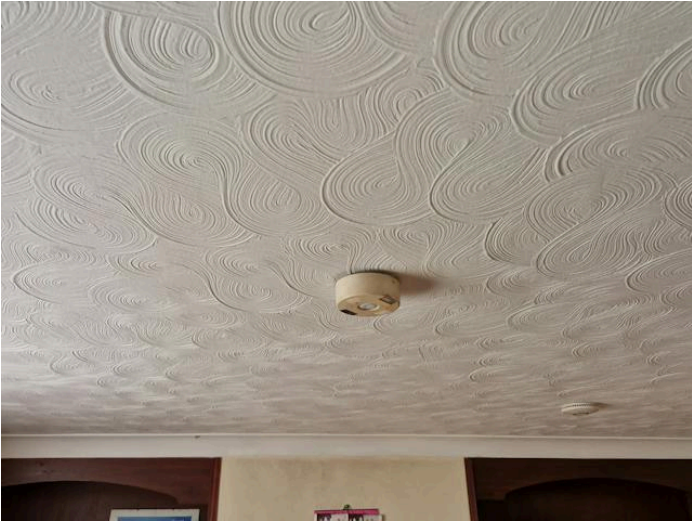
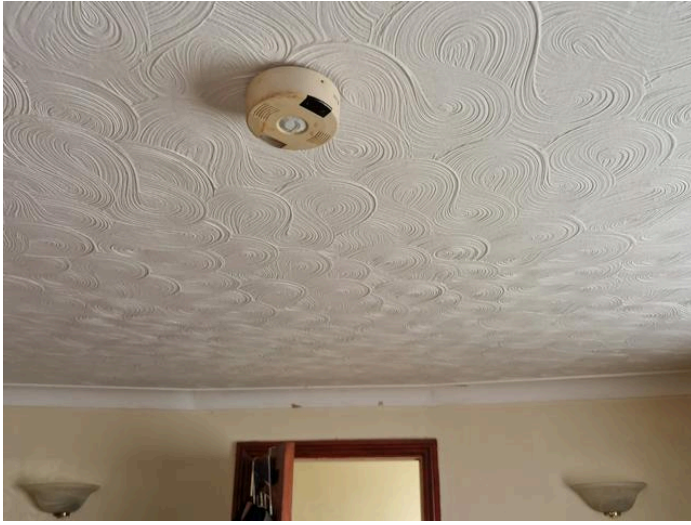
## Main Building > 0 > 011 - Lounge > Textured coating to plasterboard ceiling

Building	Main Building	Level	0
Location	011 - Lounge	Item	Textured coating to plasterboard ceiling
Material	Textured coating	Extent	14 m. sq.

Strategy / Sample Id	Strongly Presume / Sample 2	Presumed Fibre Type	Chrysotile
Recommendation	Remove if planned works may disturb

Product Type (or Debris from Product)	1	Extent of Damage / Deterioration	1
Surface Type / Treatment	1	Asbestos Type	1
Material Score	4 / Very Low

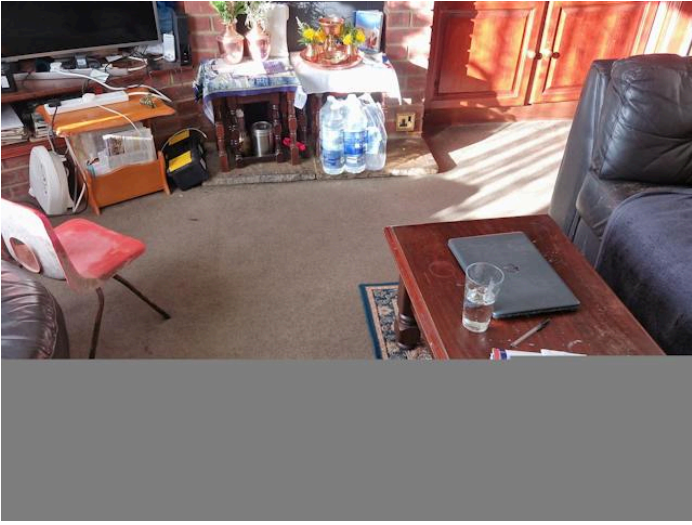
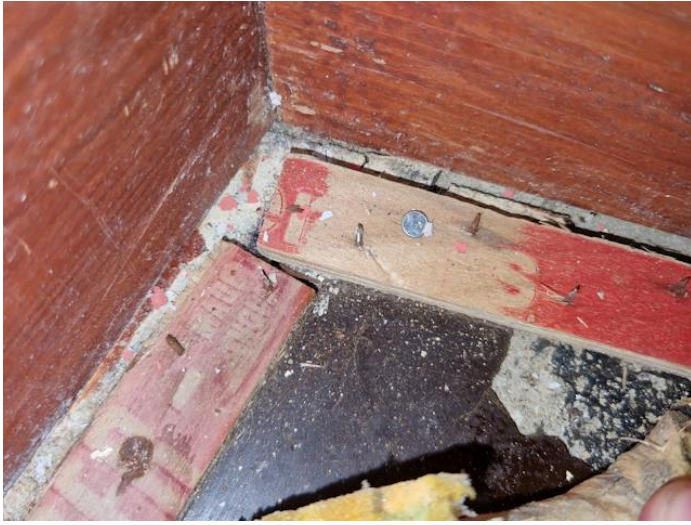
## Main Building > 0 > 011 - Lounge > Floor tiles with bitumen adhesive beneath carpet

Building	Main Building	Level	0
Location	011 - Lounge	Item	Floor tiles with bitumen adhesive beneath carpet
Material	Thermoplastic Floor Tile	Extent	14 m. sq.

Strategy / Sample Id	Strongly Presume / Sample 5	Presumed Fibre Type	Chrysotile
Recommendation	Remove if planned works may disturb

Product Type (or Debris from Product)	1	Extent of Damage / Deterioration	1
Surface Type / Treatment	0	Asbestos Type	1
Material Score	3 / Very Low

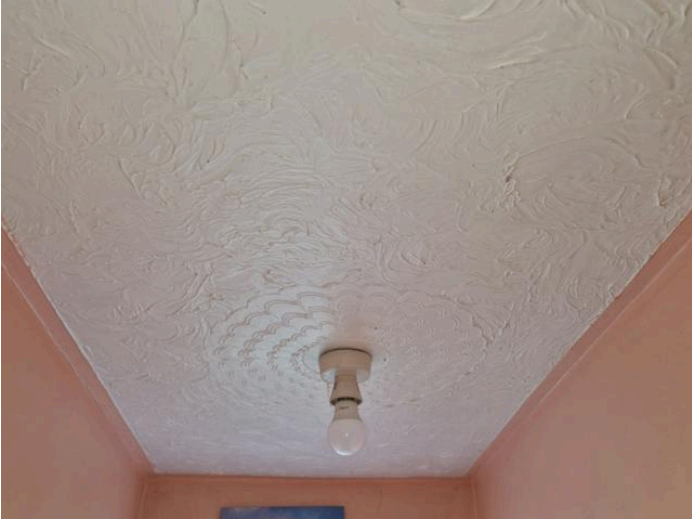
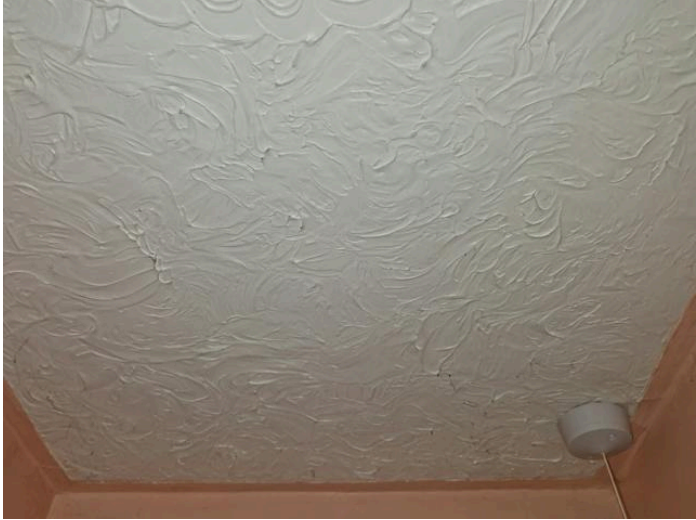
## Main Building > 1 > 004 - WC > Textured coating to plasterboard ceiling

Building	Main Building	Level	1
Location	004 - WC	Item	Textured coating to plasterboard ceiling
Material	Textured coating	Extent	2 m. sq.

Strategy / Sample Id	Sample / Sample 3	Fibre Type	NADIS

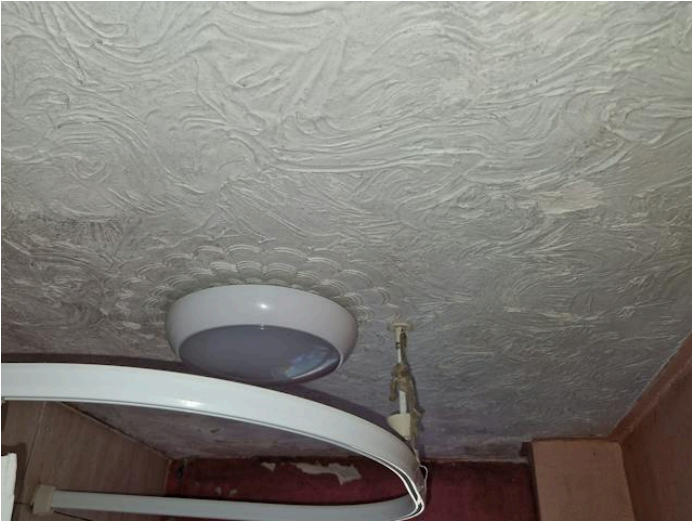
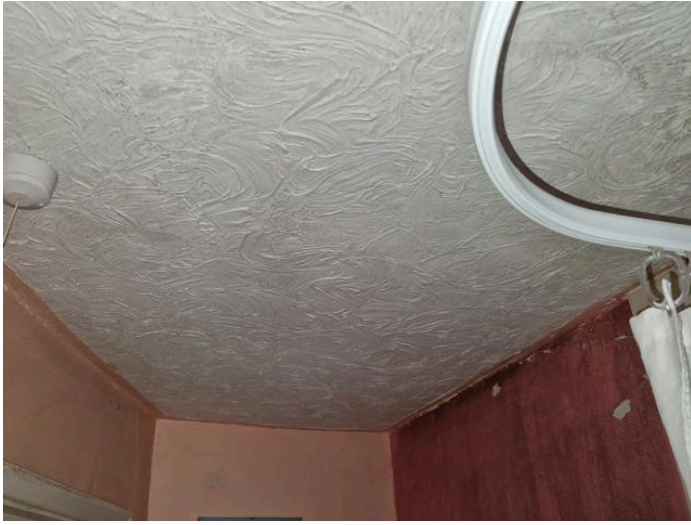
## Main Building > 1 > 005 - Bathroom > Textured coating to plasterboard ceiling

Building	Main Building	Level	1
Location	005 - Bathroom	Item	Textured coating to plasterboard ceiling
Material	Textured coating	Extent	6 m. sq.

Strategy / Sample Id	Strongly Presume / Sample 3	Presumed Fibre Type	NADIS

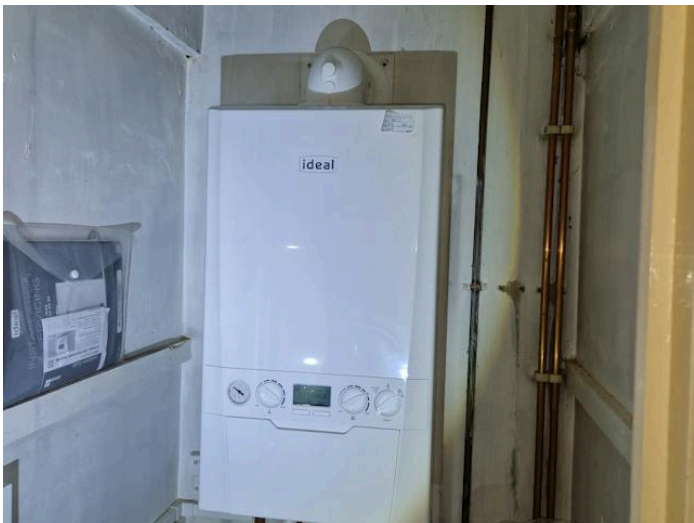
Main Building > 1 > 006 - Boiler Cupboard > Location Notes

Location Notes	Plasterboard ceiling with plaster skim finish, brick and plaster walls with plaster skim finish, wood floorboards beneath modern linoleum flooring, Ideal boiler with plastic flue and metal pipework

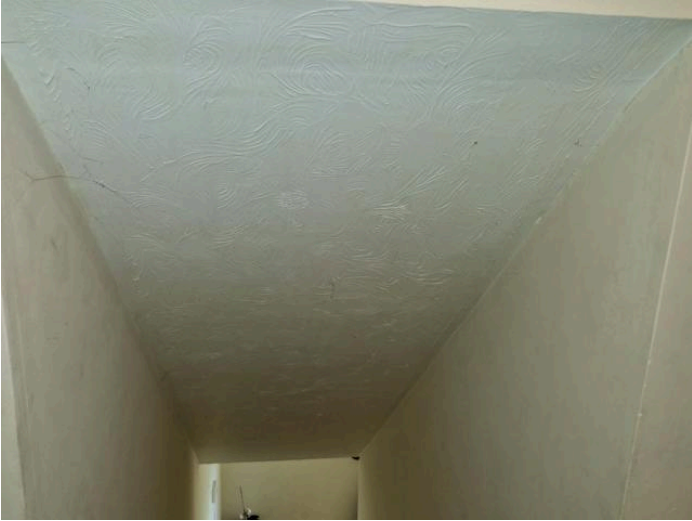
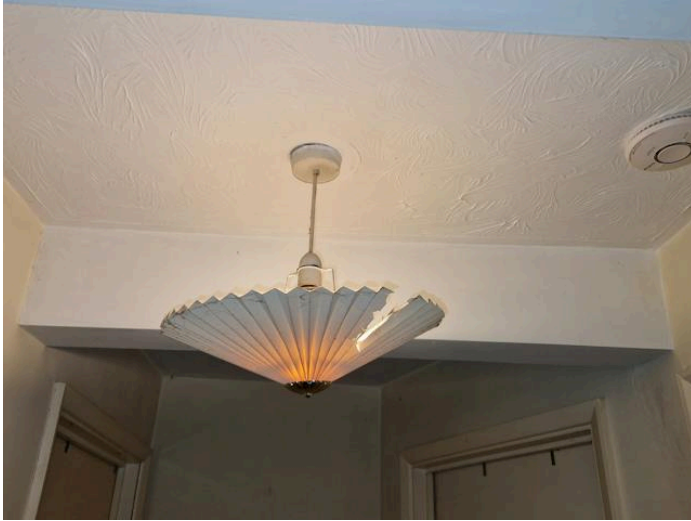
## Main Building > 1 > 007 - Landing > Textured coating to plasterboard ceiling and above staircase

Building	Main Building	Level	1
Location	007 - Landing	Item	Textured coating to plasterboard ceiling and above staircase
Material	Textured coating	Extent	9 m. sq.

Strategy / Sample Id	Strongly Presume / Sample 3	Presumed Fibre Type	NADIS

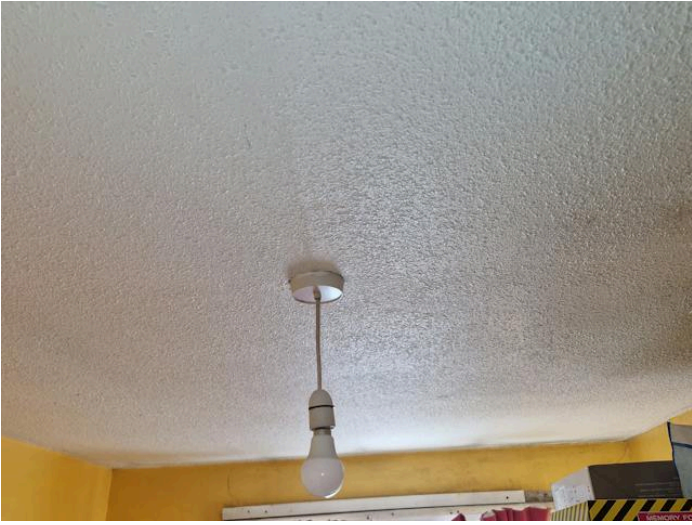
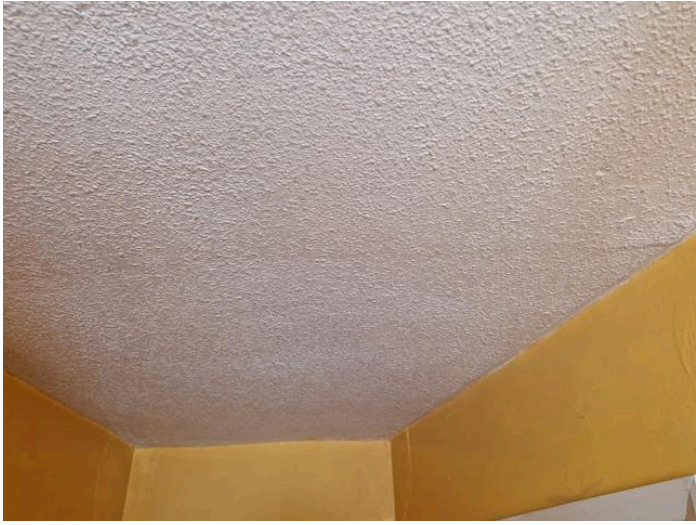
## Main Building > 1 > 008 - Bedroom 3 > Textured coating to plasterboard ceiling

Building	Main Building	Level	1
Location	008 - Bedroom 3	Item	Textured coating to plasterboard ceiling
Material	Textured coating	Extent	6 m. sq.

Strategy / Sample Id	Sample / Sample 4	Fibre Type	Chrysotile
Recommendation	Remove if planned works may disturb

Product Type (or Debris from Product)	1	Extent of Damage / Deterioration	1
Surface Type / Treatment	1	Asbestos Type	1
Material Score	4 / Very Low

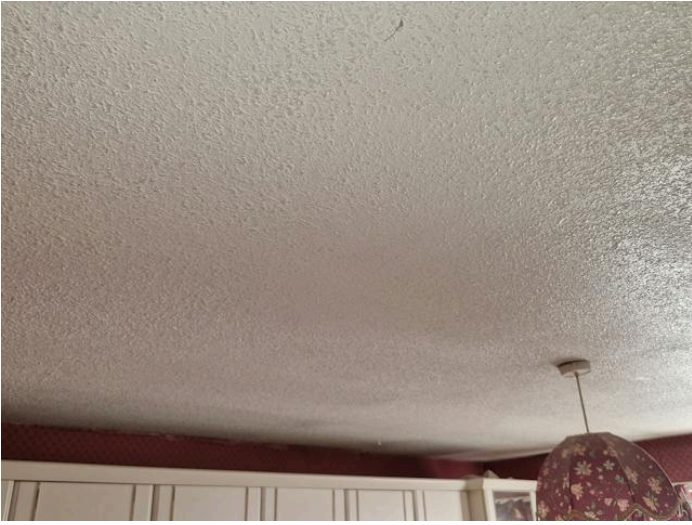
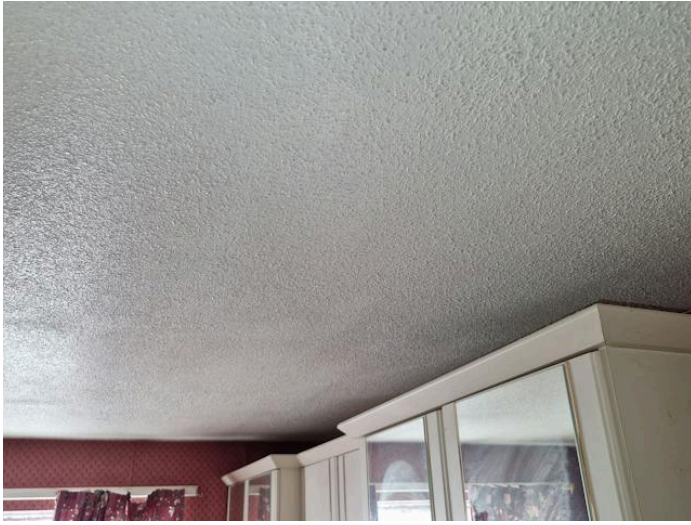
## Main Building > 1 > 009 - Bedroom 4 > Textured coating to plasterboard ceiling

Building	Main Building	Level	1
Location	009 - Bedroom 4	Item	Textured coating to plasterboard ceiling
Material	Textured coating	Extent	16 m. sq.

Strategy / Sample Id	Strongly Presume / Sample 4	Presumed Fibre Type	Chrysotile
Recommendation	Remove if planned works may disturb

Product Type (or Debris from Product)	1	Extent of Damage / Deterioration	1
Surface Type / Treatment	1	Asbestos Type	1
Material Score	4 / Very Low

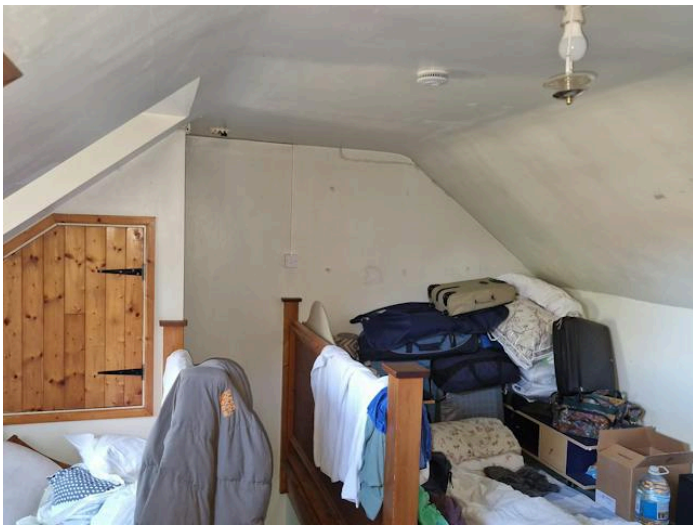
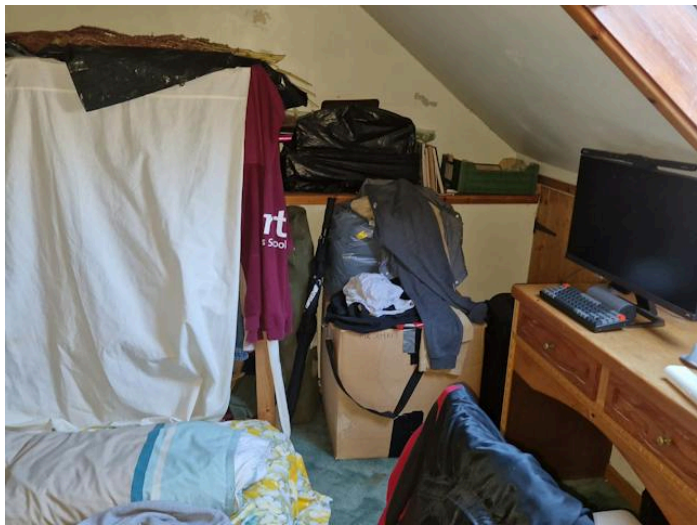
## Main Building > 2 > 002 - Bedroom 1 > Location Notes

Location Notes	Plasterboard ceiling with plaster skim finish, brick and plasterboard walls with plaster skim finish, wood floorboards beneath carpet, wood skylight with wood surround panels uPVC windows with wood sill, no suspect materials found within cupboard

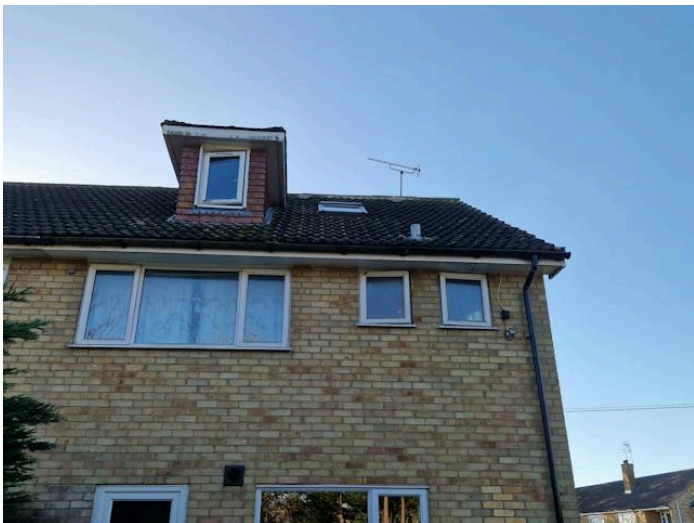
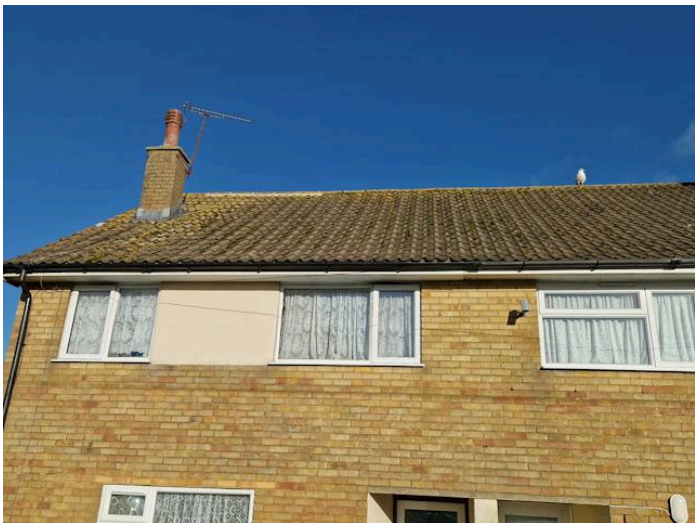
Main Building > External > 013 - External Elevations > Location Notes

Location Notes	Stone roofing tiles, plastic guttering and downpipes, plastic fascia panels, plastic soffit boards, brick walls, upvc windows with modern mastic, metal and plastic flue, brick chimney stack with lead flashing and clay cowl

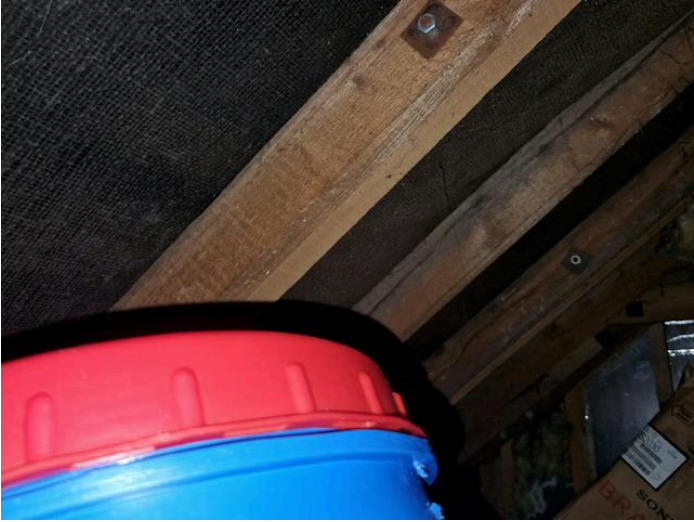
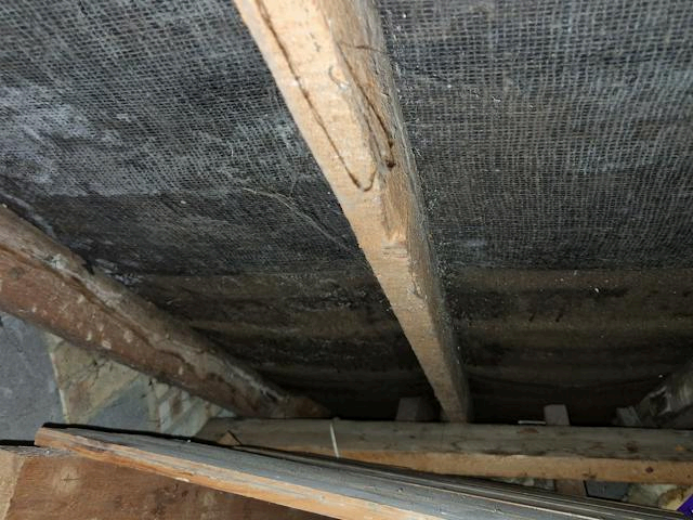
Main Building > Roof > 001 - Roof Void > Bitumen roofing felt

Building	Main Building	Level	Roof
Location	001 - Roof Void	Item	Bitumen roofing felt
Material	Bituminous Felt	Extent	100 m. sq.

Strategy / Sample Id	Sample / Sample 1	Fibre Type	NADIS
